EVG HELPED SCA ORTVIKEN PM1 TO IMPROVE WIRE SECTION PERFORMANCE

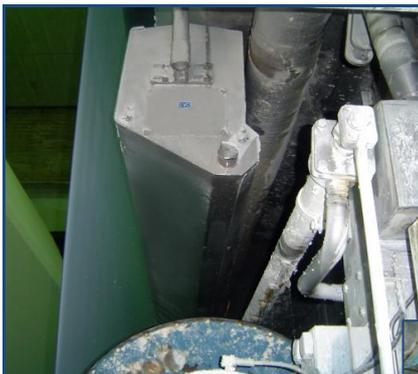
EV MRS at bottom wire

At the bottom wire, high pressure wire cleaning shower was spreading very misty air with fibers and fillers in the area, because the old type of mist suction box of the area operated with very poor performance.

To solve these problems, EV Group offered the mill technology for top wire ventilation and modern bottom wire mist removal (EV MRS™) for high speed paper machines. Installation took place in May, 2008. The mill experience shows the wire section performance has clearly improved after the project.
