EVG HELPED SCA ORTVIKEN PM1 TO IMPROVE WIRE SECTION PERFORMANCE

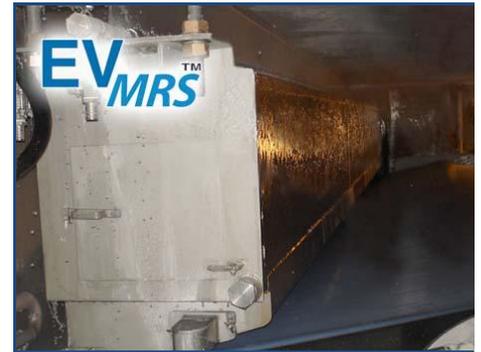
At the bottom wire, high pressure wire cleaning shower was spreading very misty air with fibers and fillers in the area, because the old type of mist suction box of the area operated with very poor performance.

EV MRS at bottom wire

To solve these problems, EV Group offered the mill technology for top wire ventilation and modern bottom wire mist removal (EV MRS™) for high speed paper machines. Installation took place in May, 2008. The mill experience shows the wire section performance has clearly improved after the project.
